No VNWA sound devices detected after upgrade to Windows 10 feature release 1703

Jan Verduyn SDR-Kits - 20th November 2017

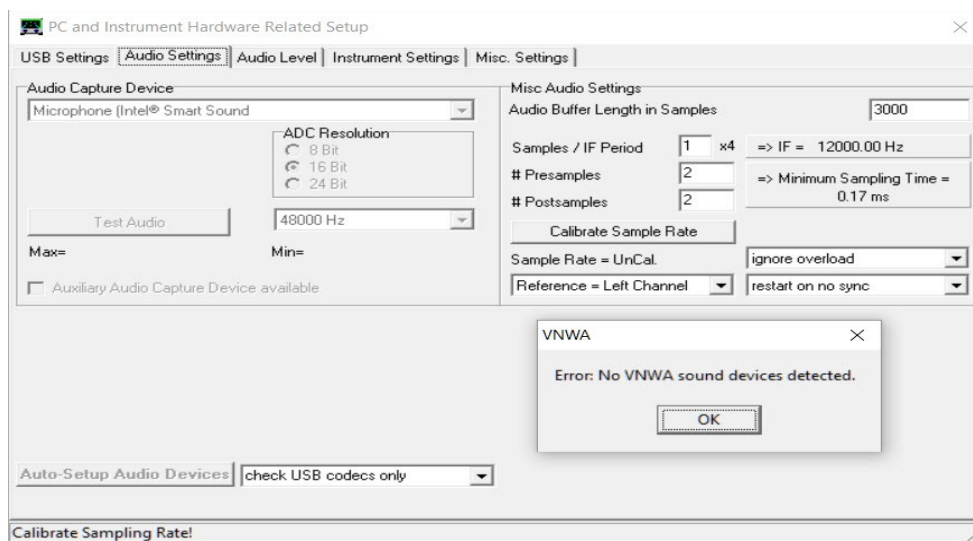
A number of VNWA users have found that one or both USB Codecs are no longer visible after starting the VNWA Application and the VNWA fails to operate. The reported error is “**No VNWA sound devices detected**”

It appears that the Windows 10 1703 upgrade detects the presence of the USB Codec devices, previously used with the VNWA Application however the W10 upgrade then changes the status of the USB Codec Devices to **DISABLED**. Moreover after the upgrade any Disabled Devices are **No longer shown** in the Tab **Settings – Sound – Recording**.
